# ASSESSING FLOW-ACCELERATED CORROSION IN HARD-TO-REACH PLACES

A high-temperature, high-velocity fluid races toward a 90° bend in an insulated carbon steel pipe. The outcome is inevitable: flow-accelerated corrosion (FAC) at the elbow’s extrados on the inner surface of the pipe.

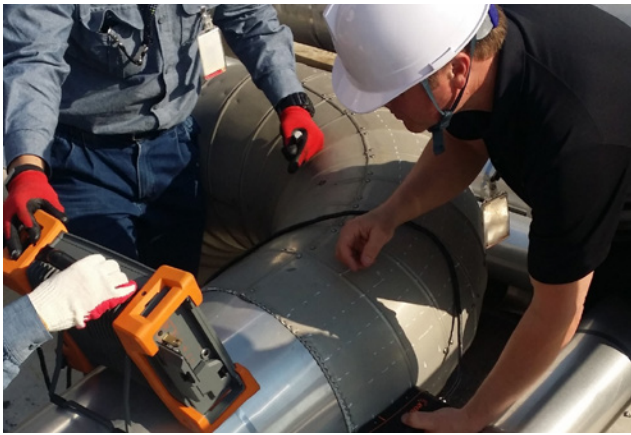
Grid scan of elbow extrados

did not allow the encoder to operate properly). A 50x50 mm (2x2 in) grid was mapped out on the surface of the elbow so that the scan area was the elbow's extrados (where FAC was most likely to occur).

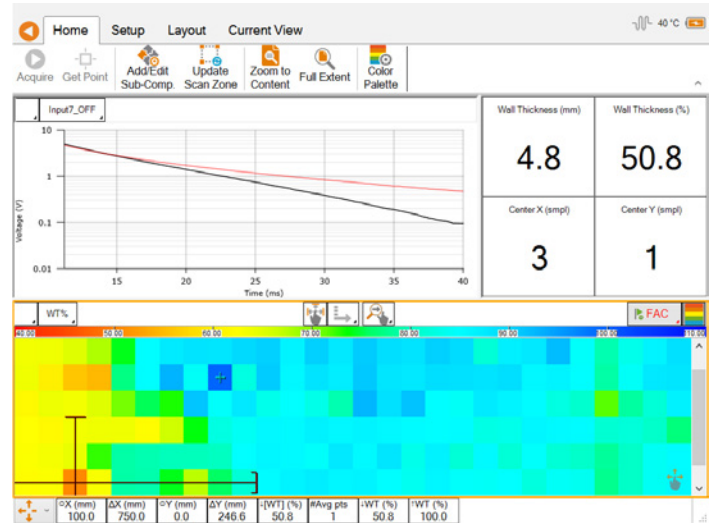
Elbow grid scan results

Inspection results indicated substantial wall loss concentrated at the bend transition and continuing through the extrados of the elbow, the extent of which was not anticipated.
