INSPECTING SUBMARINE HULLS FOR CORROSION

Elaborating an NDT method able to inspect submarine hulls and characterize damage without having to remove acoustic/anechoic tiles.

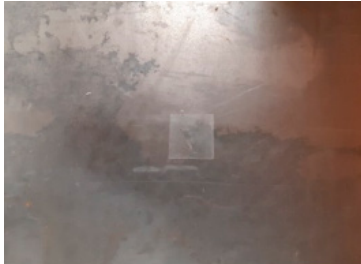
ECA custom probe scanning over a 30 mm thick rubber tile with a 1 mm thick plastic film placed underneath

To simulate disbonding, a 30 × 30 × 1 mm (1.18 × 1.18 × 0.04 in) plastic tile was placed on a steel plate, covered by a rubber tile. As the probe moved over the insulation, the additional lift-off caused by the presence of the plastic sheet was clearly detected.

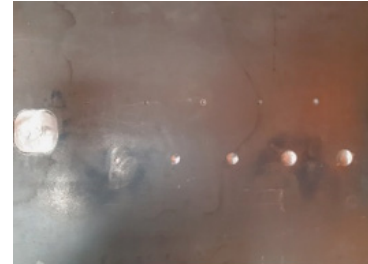
ECA custom probe on various round bottom holes over a 30 mm rubber tile

The current ECA probe, used on a plate with round bottom holes, could comfortably detect a 15-mm (0.6-in) wide by 3-mm (0.1-in) deep defect. All that under a 30 mm (1.2 in) thick rubber tile.
